Multiscale fracture analysis along the French chalk coastline for investigating erosion by cliff collapse

Albert Genter¹, Anne Duperret², Alexandra Martinez², Rory N. Mortimore³,

Special issue: "Coastal chalk cliff instability"

Abbreviated title : Fractures and coastal cliff collapse

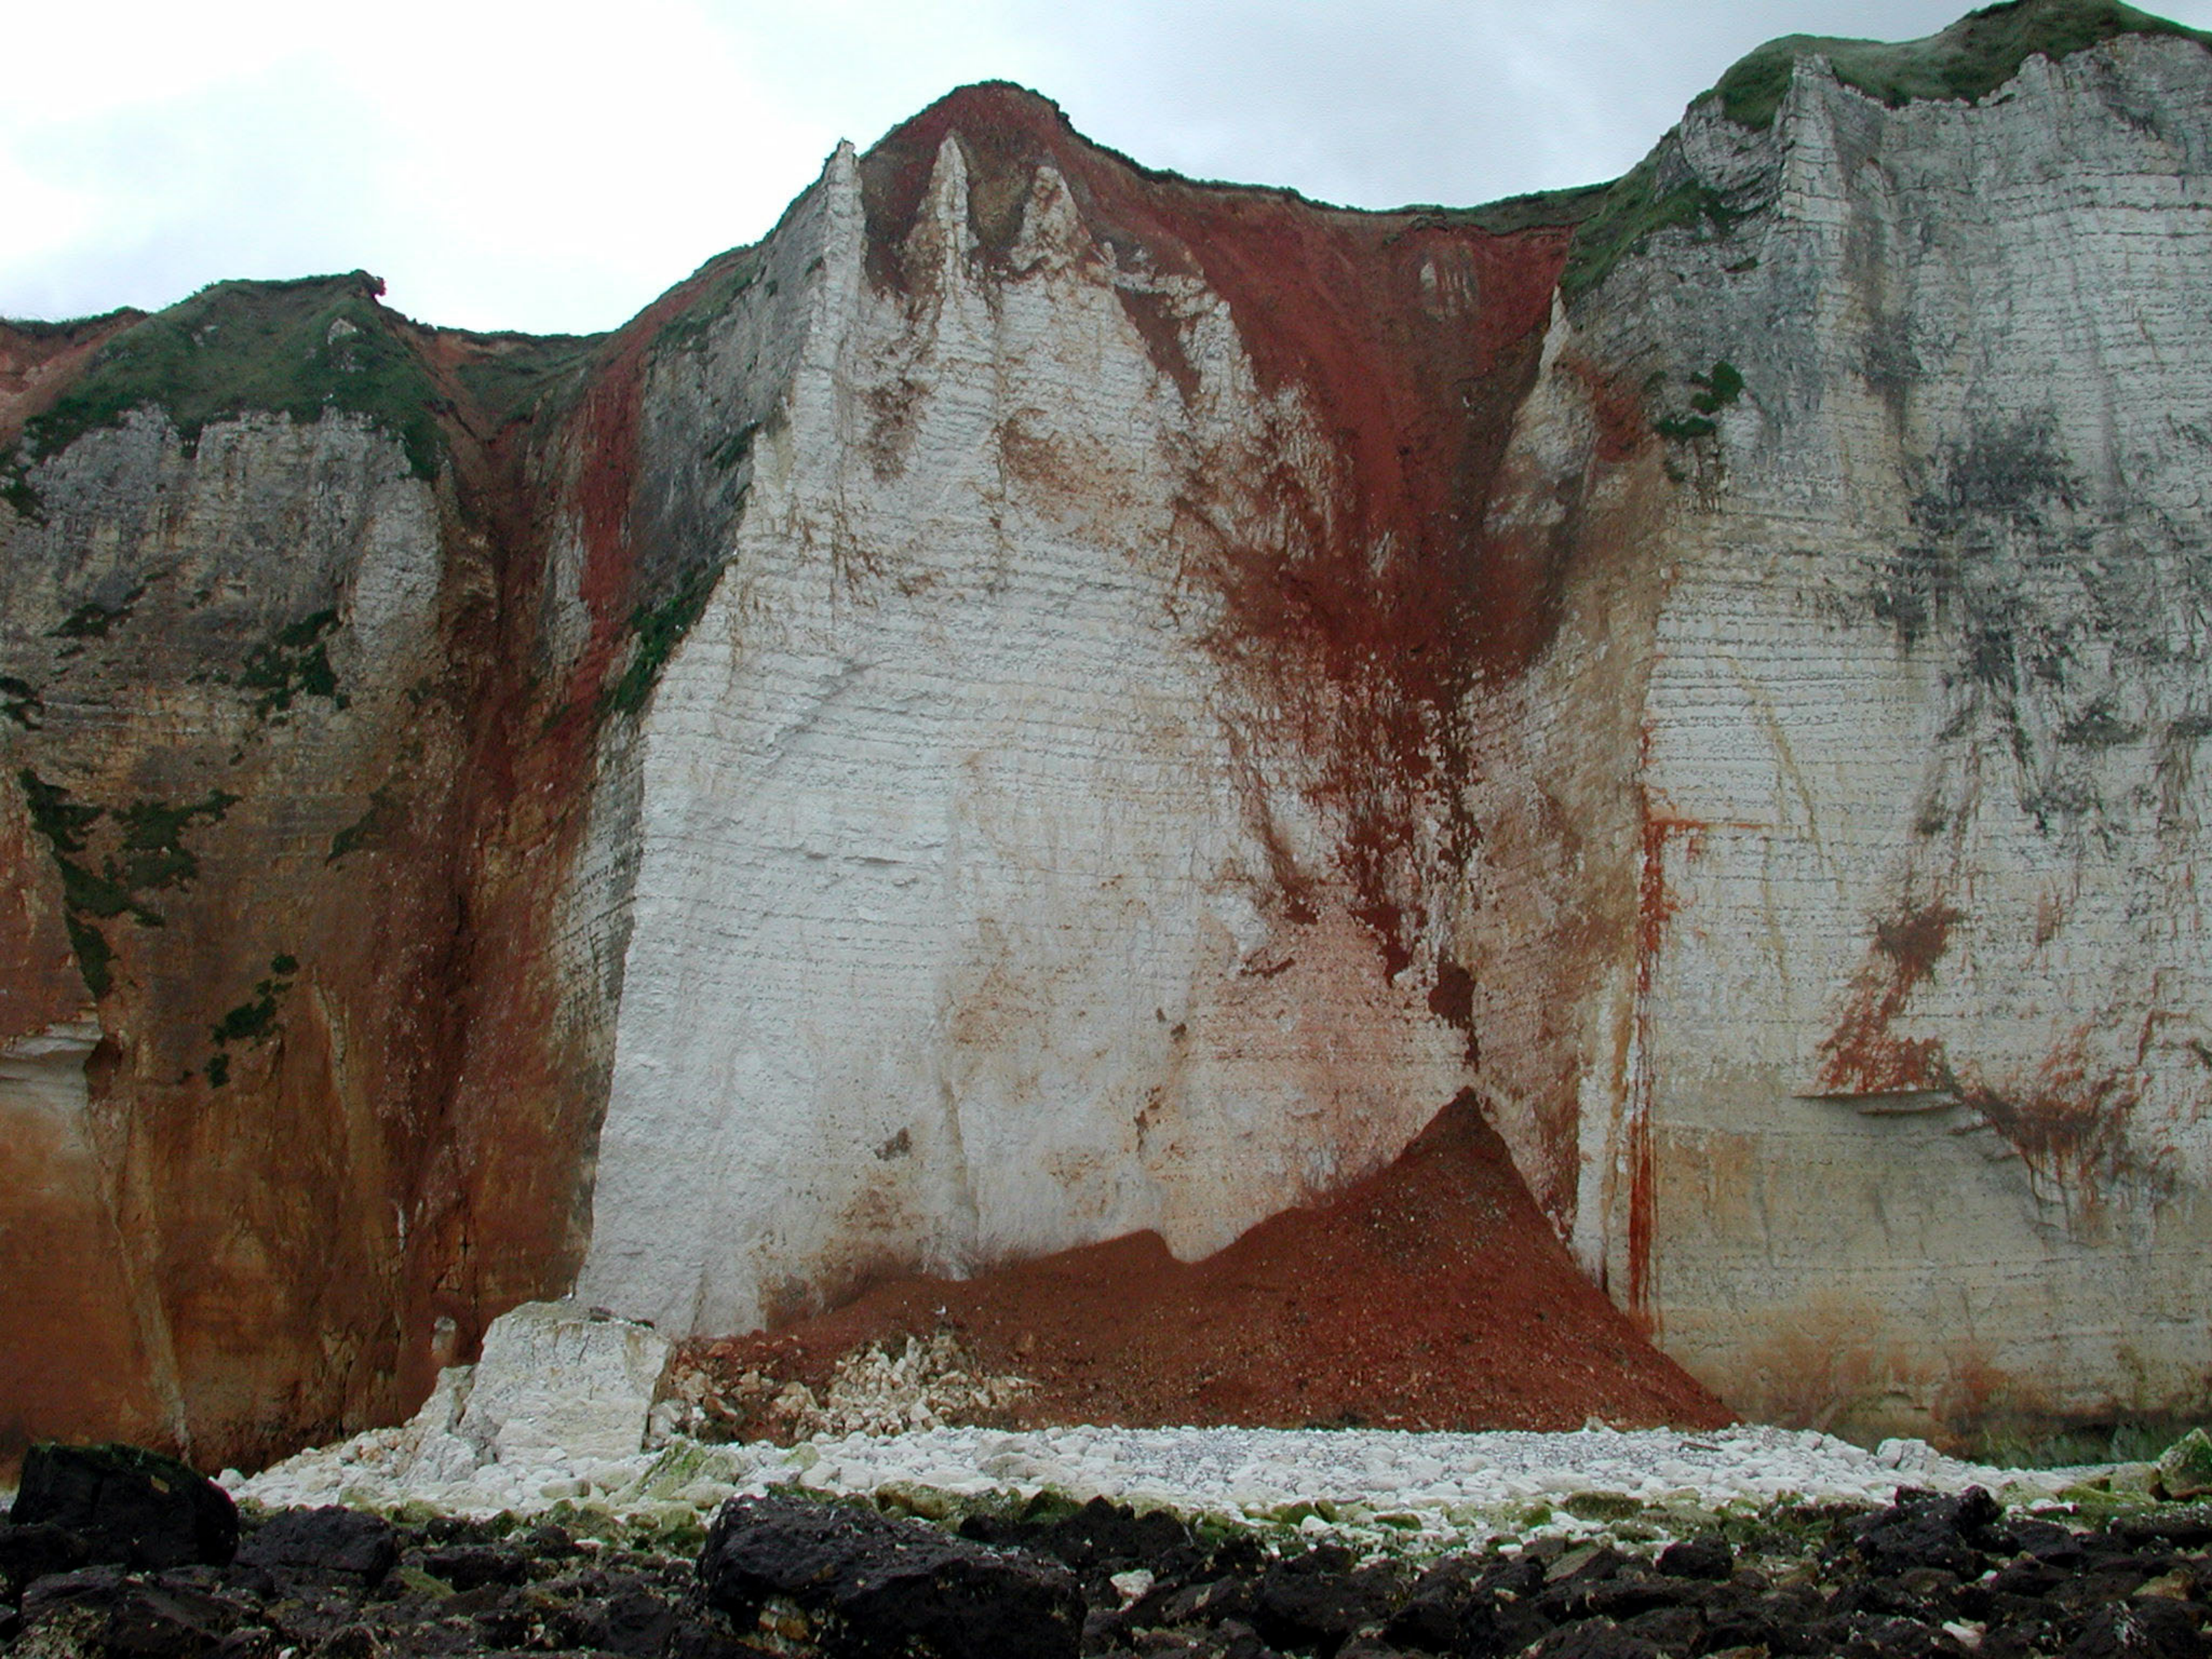
Fig. 11 : Example of recent collapse at St Pierre en Port, that occurred on March the 15th 2001, showing a scar bounded laterally by a pre-existing vertical fracture. The total cliff height is about 90 m
